# In Situ Transmission Electron Microscopy Observations of Forward Bias Degradation of Vertical Geometry $\beta$ -Ga<sub>2</sub>O<sub>3</sub> Rectifiers

To cite this article: Zahabul Islam et al 2020 ECS J. Solid State Sci. Technol. 9 055008

The microstructural changes and degradation under forward bias of vertical  $\beta$ -Ga<sub>2</sub>O<sub>3</sub> rectifiers were observed by in-situ transmission electron microscopy. The devices show both a voltage dependence for the onset of visible degradation as well as a time dependence at this threshold voltage, suggesting a defect percolation process is occurring. The degraded rectifiers show a large decrease in forward current and different types of crystal defects are present, including stacking fault tetrahedra, microcracks, Ga-rich droplets and Au inclusions from the top electrode. Continued forward bias stressing is known to lead to macro-cracks oriented along the [010] crystal orientation and eventual delamination of the epitaxial drift layer, but this study is the first to provide insight into the appearance of the smaller defects that precede the large scale mechanical failure of the rectifiers. The initial stages of bias stress

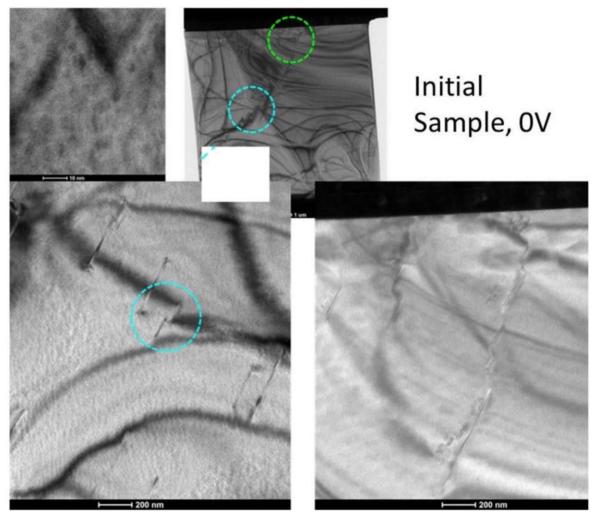
The rectifiers were examined by TEM for the presence of defects in the as-fabricated devices prior to any biasing. Figures 2 and 3 show cross-sectional images of the rectifiers, in which a variety of

defects are observed. These include threading dislocations, rod-shaped defects common to  $\beta$ -Ga<sub>2</sub>O<sub>3</sub> and stacking faults. The high resolution image does not reveal the presence of any divacancy-interstitial complexes that have been reported in Sn-doped bulk Ga<sub>2</sub>O<sub>3</sub>. Previous work has also identified extended defects (e.g., twin boundaries and screw dislocations) and some atomic-scale defects in bulk and epitaxial Ga<sub>2</sub>O<sub>3</sub>. However, as will be seen below, once the rectifiers are biased, new defects appear. We observed quantitatively similar results for all coupons tested, although for consistency, we show all the images from one device since we had a complete set of images for this and for the others we had less complete data.

Figure 2. TEM cross sectional views of rectifier prior to forward bias stressing, showing presence of extended defects.

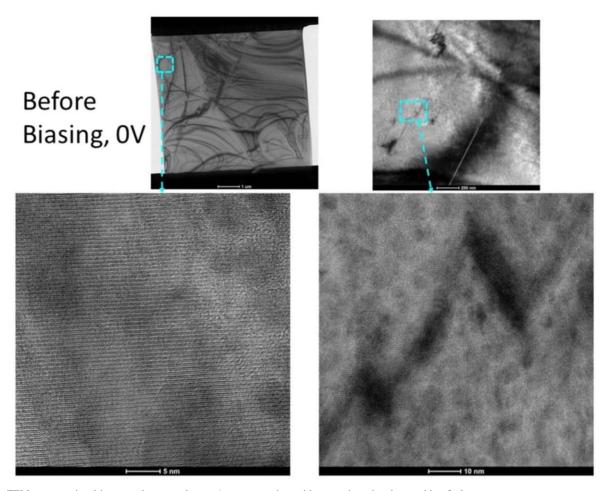
Figure 3. TEM cross sectional images taken near the top Au contact prior to bias stressing, showing stacking faults.

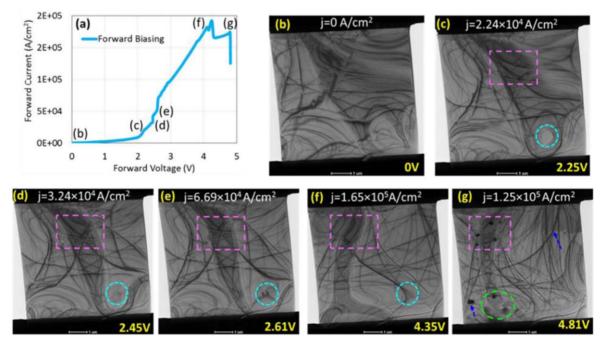
Figure 4. (a) I-V characteristics under forward biasing condition; TEM bright field images at different biasing voltages: (b) 0 V, (c) 2.25 V, (d) 2.45 V, (e) 2.61 V, (f) 4.35 V, and (g) 4.81 V.

box and cyan color dotted circle in Fig. 4c. As the forward bias is increased to 2.45 V (corresponding I-V characteristic is indicated by point (d) on Fig. 4a), a change in the slope of the I-V characteristic is

evident. This slope change signals the onset of crystal defect generation due to the high current density (3.24  $\times$  10<sup>4</sup> A.cm<sup>-2</sup>), which further increases the series resistance of the sample. <sup>33–35</sup>

Points (d) to (e) in Fig. 4 show an abrupt and sharp current density increment from 2.45 V to 2.61 V. This behavior may be explained by increased defect generation rate due to heating and increased carrier energy. At high forward biases, carriers gain sufficiently high energy, and both barrier potential and bandgap are reduced<sup>37</sup> which could counter-balance the rate of defect generation at this moderate current density (compared to the breakdown current density). Beyond 2.61 V, the current density is high enough to introduce more defects in the device, which is even visible at low magnification, as shown in Fig. 4f. The increase of bias from 2.61 to 4.35 V(points (e) to (f) on Fig. 3a) clearly indicates an additional change in slope of the I-V curve, which could be attributed to the more pronounced effect of carrier traps and series resistance in the device. At 4.35 V forward bias current density is  $1.65 \times 10^5 \,\mathrm{A\,cm^{-2}}$ , which could induce sufficiently high thermal stress and micro-structural defects due to the moderate thermal conductivity of Ga<sub>2</sub>O<sub>3</sub>. This is reflected by point (f) in Fig. 4a where current drops sharply. After 4.35 V forward bias, the output current value slightly increased as marked by point (g) on Fig. 2a. However, series resistance at this point is a maximum during forward biasing. At 4.81 V, current density is more than two orders of magnitude higher than the reported<sup>21,34</sup> threshold value for failure, and current drops, as shown in Fig. 4a. At this stage current density is high enough to introduce structural degradation due to the thermomechanical field, as shown by pink color dotted rectangular box and cyan color dotted circle in Fig. 4g.

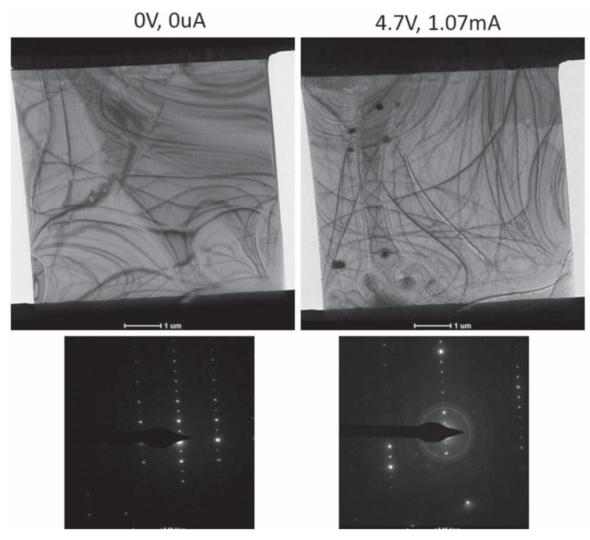
Figure 5. Cross sectional images and SAED patterns from rectifier before and after bias stressing at 4.7 V to induce degradation.

For clarity, Fig. 5 shows a side-by-side cross-sectional comparison of the rectifier before (left) and after (right) biasing to 4.7 V, where the current shows the device has significantly degraded. Note the appearance of extended defects near both the anode and cathode, as well as a degradation of the selected area diffraction pattern.

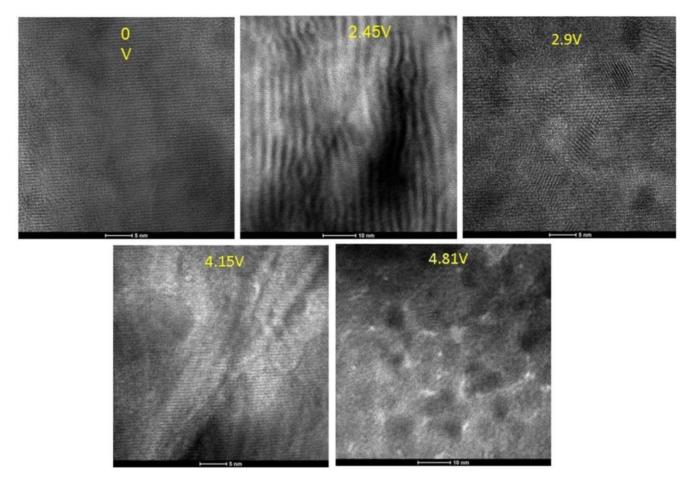
High resolution images taken in the center of the epitaxial layer for different forward biases are shown in Fig. 6. The pristine crystal quality prior to bias application is evident in the 0 V image. However, various degrees of lattice disorder become apparent as the bias is increased up to 4.8 V. Note that changes are already obvious at 2.45 V (current density of 3.24  $\times$   $10^4$  A.cm $^{-2}$ ). This correlates with electrical measurements, which shows that irreversible damage to the rectifiers occurs for temperatures in the drift region above  $\sim$  270 °C and at temperatures above 350 °C the Aubased metallization fails.  $^{38}$

Figure 6. Higher resolution cross-sectional images as a function of forward bias on the rectifiers, showing the change in crystal quality.

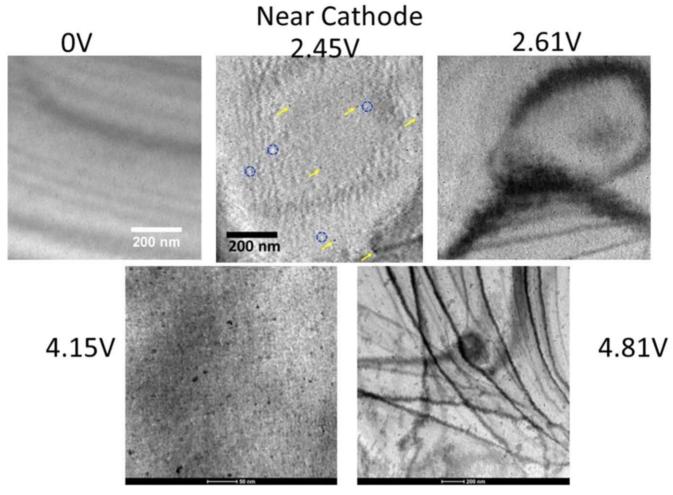
A more detailed view of the spatial variation in defect introduction is shown in Figs. 7 and 8, which show cross-sectional images take from near the cathode (Fig. 6) and anode (Fig. 7), respectively, as a function of forward bias. Near the cathode (Ti/Au contact), the appearance of defect clusters are apparent as the bias increases until the appearance of an extended defect at the failure point. A similar trend is obvious near the Au anode, where defects with size  $\sim\!100\,\mathrm{nm}$  appear at the failure point. We subsequently performed EDS to gain insight into the chemical composition of these defects. It is also worth noting that the diffraction patterns at the failure point,

Figure 7. Cross-sectional images near the Ti/Au cathode, as a function of forward bias during electrical stressing.

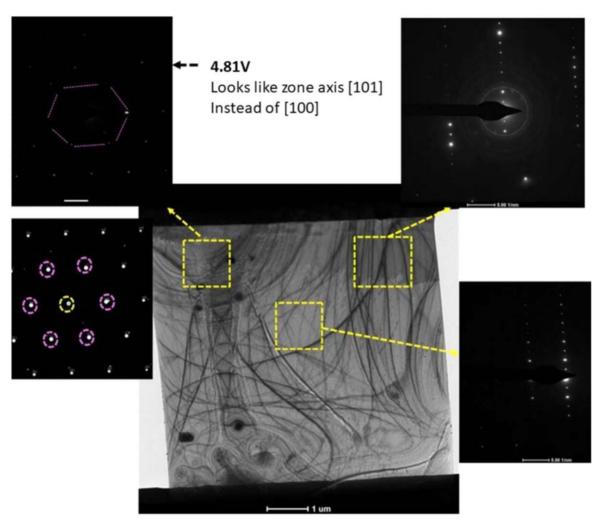
even away from the extended defects, showed significant changes. Figure 9 shows diffraction patterns taken at three different locations near the top of the rectifier structure where the heating during forward biasing will be most severe. There is even an indication of a change in zone axis in this region.

Figure 9. SAED from three regions near the top Ni/Au contact after forward bias stressing at 4.81 V.

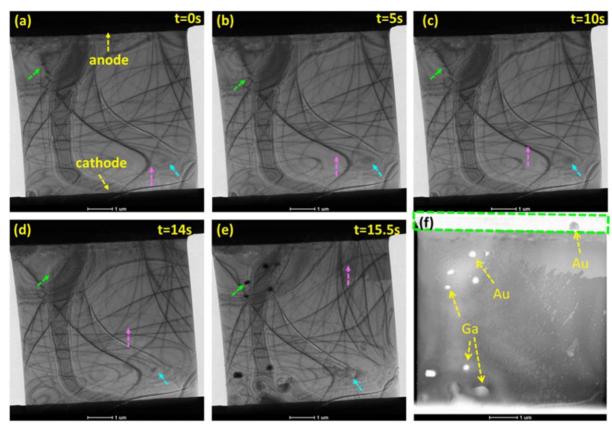
A time series analysis of the sample at 4.81 V prior to the failure is shown in Fig. 10. This provides an insight on how and where the degradation starts and propagates inside the rectifier. The green and cyan color arrows indicate regions near the anode and cathode electrode, respectively, whereas pink color arrow indicates the direction of gradual migration and evaporation. In Figs. 10a-10d, both green and cyan color dotted arrow show contrast change near the cathode, indicating microstructural changes under high current density, which further degrades after 15.5 s biasing time at 4.81 V. Pink color arrow indicates the direction of gradual contrast change with experiment time. This contrast change could be attributed to the evaporation/migration of atoms from cathode to anode side under very high current density i.e.  $1.65 \times 10^5$  A cm<sup>-2</sup>. Due to the low thermal conductivity of Ga<sub>2</sub>O<sub>3</sub> and applied high forward current density, metal pools that are Au or Ga -rich can form in the drift layer<sup>39</sup> as captured by scanning transmission electron microscope (STEM) image in Fig. 10f and confirmed by the EDS scans. The formation of Au- or Ga-rich metal particles might also result from surface diffusion of the respective elements on the surface of the thin TEM sample. At this point, we can't confirm the mechanism.

Figure 10. Time series TEM BF images of defects evolution prior to the failure at 4.81~V: (a) 0~s, (b) 5~s, (c) 10~s, (d) 14~s, (e) 15.5~s, and (f) HAADF STEM image after failure.

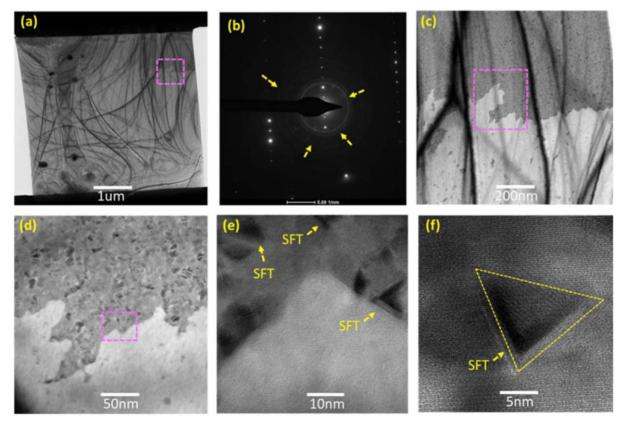
At very high current density (bias of  $4.81 \, \text{V}$ , current density  $1.25 \times 10^5 \, \text{A.cm}^{-2}$ ), the rectifier is seen to undergoes severe lattice damage and degradation, as shown in Fig. 11. The extent of the degradation during the high forward biasing could be understood using selected area electron diffraction (SAED) patterns. Such a SAED pattern is shown in Fig. 11b. Appearance of a ring (as indicated by yellow color dotted arrow) in SAED pattern clearly

indicates the device has undergone severe lattice damage. This observation is supported by Figs. 11c-11f where lattice damage and defects are evident. Figure 11g shows different types of defects, including multiple stacking fault tetrahedrons (SFT) which could be an outcome of thermal stress, and Fig. 11f shows an individual stacking fault tetrahedron at high resolution. SFT defects are obvious indicators of vacancy generation in the rectifier drift layer under high current density. These vacancies further accumulate to form SFT defects as shown in Figs. 11e and 11f. Similar types of stacking fault defects in  $Ga_2O_3$  has been reported recently.  $^{32-35}$

Figure 11. (a) Low magnification TEM BF images after failure i.e. at 4.81 V, (b) SAED pattern after failure, (c)–(d) magnified view close to the center area as shown by pink color dotted rectangle, (e) HRTEM images showing SFT defects in a defected region of the sample, and (f) HRTEM images of an individual SFT defect.

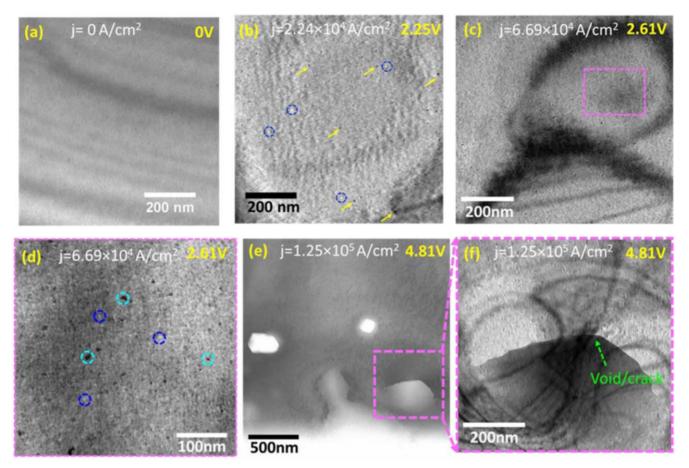
$\beta$ -Ga<sub>2</sub>O<sub>3</sub> rectifiers can suffer generation of generate cracks and defects at electrodes as well as in the device layer under forward biasing conditions. <sup>18,36,38</sup> Figure 12 illustrates such defect evolution in the drift layer during the forward biasing. Additional extended defects observed as the forward bias was increased included voids and microcracks. We did not notice any crystal defects before forward biasing, as shown in Fig. 12a. Beyond the threshold current density of  $2.24 \times 10^4$  A cm<sup>-2</sup>, minor crystal defects starts to arise, as indicated by the circular regions in Fig. 12b. These defects are more evident at  $6.69 \times 10^4$  A cm<sup>-2</sup> as shown in Fig. 12c. Figure 12d shows a magnified view of Fig. 12c, where both extended defects

and clusters are evident. These defects near the anode could affect Schottky barrier height at the interface, <sup>37</sup> which would further affect forward output current. Above 2.61 V forward biasing, which corresponds to  $6.69 \times 10^4 \text{ A cm}^{-2}$ , thermal stress induces a significant amount of crystal defects, which further reduce forward current. This is supported by the corresponding I-V characteristic, which showed an increase in sheet resistance. With increased forward bias voltage, the rectifier failure is accompanied by formation of vacancy enriched areas, as indicated in Figs. 12 d and 12e. We also noticed a disruption in crystal structure and formation of small crystallites. This indicates the single crystal Ga<sub>2</sub>O<sub>3</sub> disintegrates to a polycrystalline structure, which significantly affect the device performance. These defects act as carrier traps and might increase series resistance of the rectifiers. Thus, defects induced series resistance increment further degrades forward output current. During the failure both metal pool (green color dotted circle) and discernable cracks (pink color dotted rectangle) formed in the device layer near the cathode as shown in Figs. 12e and 12f. A magnified view of the crack is shown in Fig. 12f. This current density is higher than the reported breakdown value, which could induce sufficient amount of thermal stress in the device layer and initiate mechanical cracking. <sup>21,34</sup> The formation of pores and cracks could also be related to surface diffusion and bending of the thin TEM lamellae, although as discussed earlier, the lamellae behave in a similar fashion to the large area, ex-situ devices.

Figure 12. Defect evolution during the forward biasing at: (a) 0 V, (b) 2.25 V, (c) 2.61 V, (d) magnified view at 2.61 V, and (e) HAADF image at 4.81 V, and (f) TEM BF image at 4.81 V.
